TRU WASTE PILOT RETRIEVAL

618-10/11 Workshop June 10, 2003 Ken Hladek

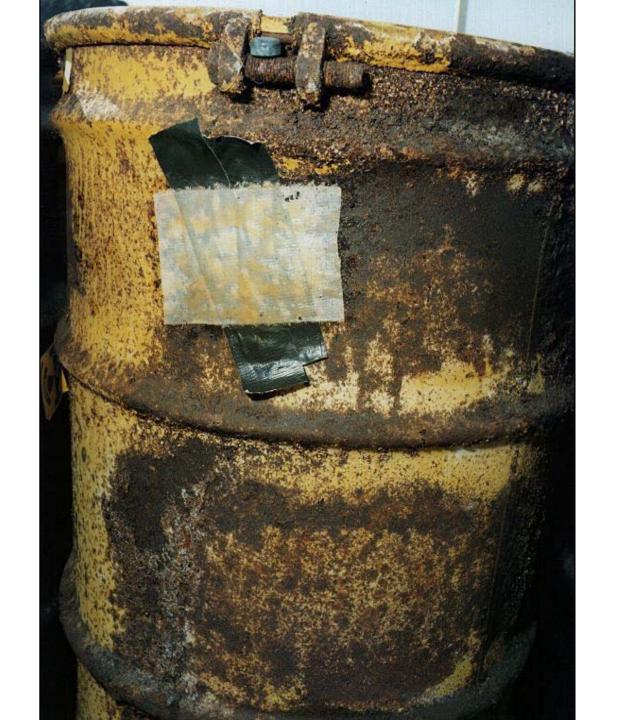
- Follow-on Activities (continued):
 - Continued Drum Retrieval
 - Conducted NDE on drums deeper in stack
 - Found an area of higher than expected radiation
 - Some minor drum identification differences
 - One Drum with Pinholes
 - Two pencil sized penetrations
 - Located where tarp had been in contact
 - No radiation contamination
 - Drum sealed and left in place

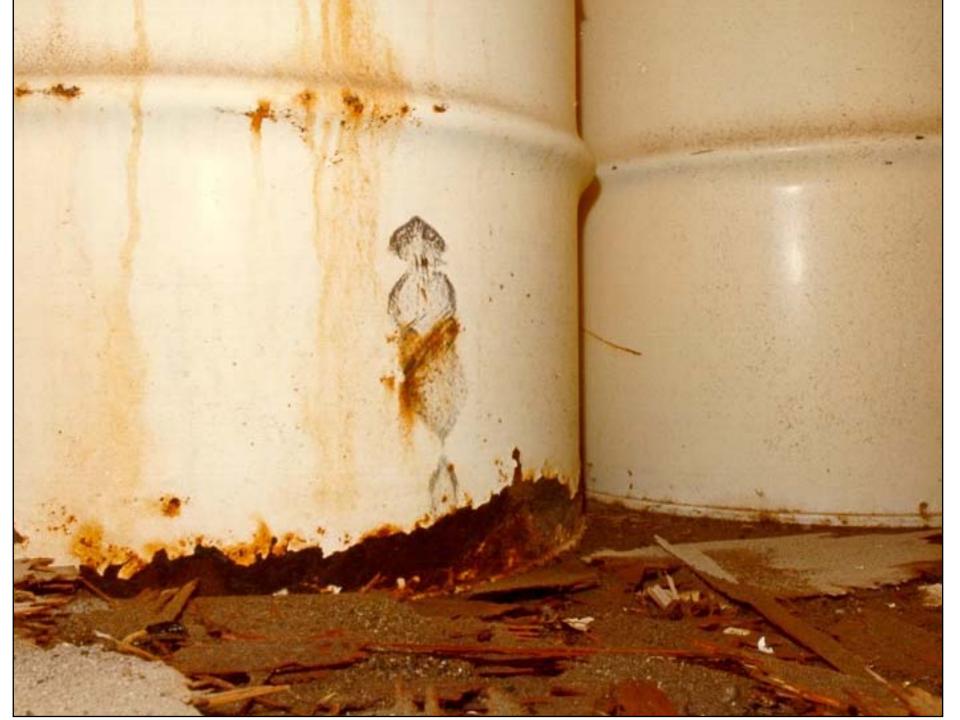
- Follow-on Activities (continued):
 - Corrosion at Bottom of Drum an Integrity Concern
 - Unable to tell extent of corrosion visually
 - NDE not effective in "rough" area
 - Operators wanted assurance of structural integrity
 - Modified procedure to tip drum slightly and insert support plate under drum
